REPORT OF COAL-MINE OUTBURST  
BROOKSIDE MINE  
KENTUCKY JELICO COAL COMPANY, INCORPORATED  
BROOKSIDE, HARLAN COUNTY, KENTUCKY

April 9, 1963

J. L. Gilley  
Mining Health and Safety Engineer

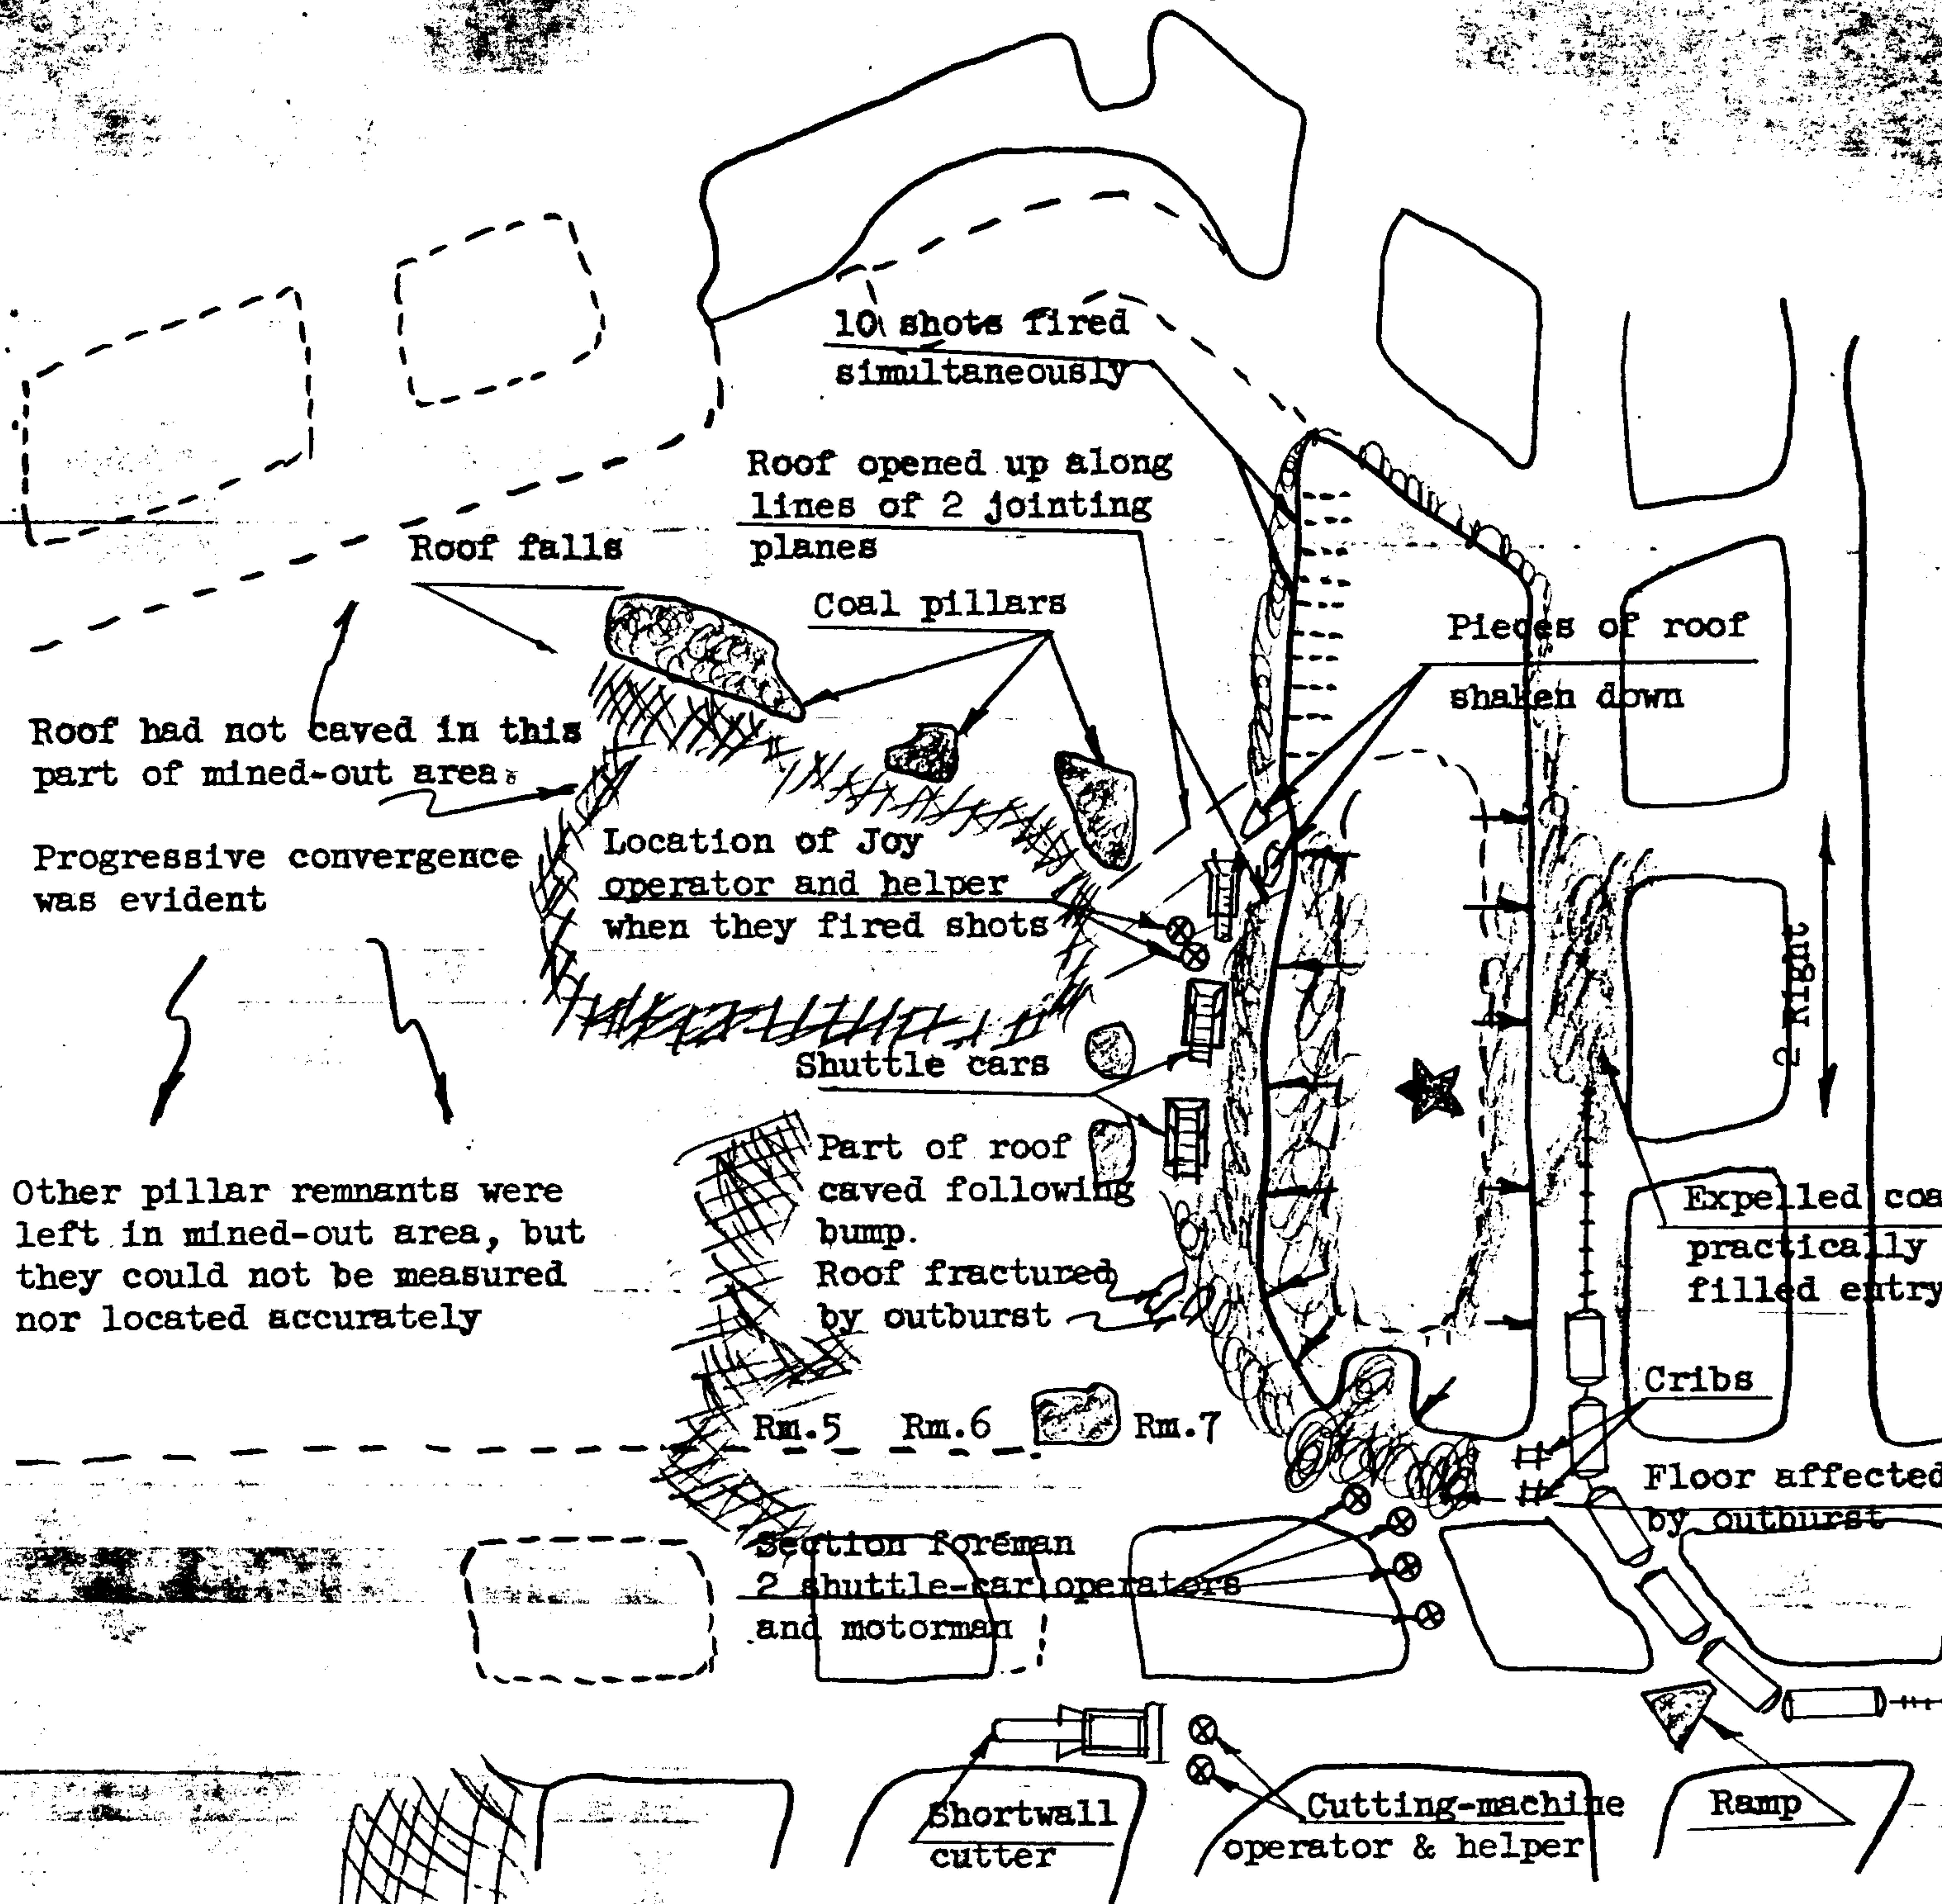
SKETCH A

Mining in the K-Main face entry section at the time of the outburst consisted of the extraction of the right and left barrier pillars and the entry chain pillars. The extent of development and the limit of pillaring the K-Main face section on the day of the bump are indicated in sketches A and B. It will also be noted from sketch A that the K-Main entry section is flanked on the right side by old workings of an abandoned mine. Rooms had been driven into the intervening barrier toward the old mine workings at several locations and had intersected the old mine workings. From sketch A it will be noted that the left and right barrier pillars were being extracted simultaneously. The 2 right barrier pillar was originally polygonal (pentagon) in shape and was 300 feet in length, 180 feet in width at the outby end, 240 feet wide at the thickest part (apex) and 160 feet in width at the inby end. However, on the date of the outburst, this barrier pillar had been reduced to a comparatively long and narrow rectangular pillar, as indicated in sketch B. The left barrier was rectangular and was 320 feet in length and 220 feet in width, but had been reduced to about one-third the original dimensions at the time of the outburst.

The outburst was violent in nature and extensive in that 4 pillars, in addition to the one involved, were affected to various degrees. Coal was expelled violently from the front and back sides of the right barrier pillar; the back of the pillar was affected for 110 feet along the face and for as much as 25 feet over the top of the pillar. Coal was expelled or shaken from along the entire length of the front side (entry side) of the pillar, and for a distance of about 80 feet, the 2 right empty-track entry was practically filled with coal (see sketch B). Effects of the force extended 10 feet over the top of this side of the pillar. It was estimated that 350 tons of coal were expelled and shaken from the right barrier pillar. A stratum of thin laminated sandstone roof overlying the coal was fractured for several feet along the back of the pillar and 2 pieces of this roof were detached and thrown down in the face areas. Tension cracks opened in the roof at a set of widely spaced jointing planes radiating from the pillar into the mined-out area, as indicated in sketch B. A roof fall, reportedly,

On the date of the outburst, the barrier pillar had been reduced to a long, rectangular-shaped pillar, 209 feet in length, about 54 feet in width at the outby end, and 48 feet wide at the inby end. An opening, 17 feet in width and 25 feet in depth, was driven into the outby end of the pillar to serve, reportedly, as parking or passing space for equipment which further reduced the stability of the front end of the pillar.

Joy operator and  
helper who fired shots  
(Both injured)

Force extended  
25 feet into pillar  
Approx. 350 tons of coal  
expelled from  
pillars

Coal expelled from  
pillars practically filled  
entry for 80'
